JOINT HIGHWAY RESEARCH PROJECT

FHWA/IN/JHRP-80/4

Final Report

MAINTENANCE METHODS
FOR CONTINUOUSLY REINFORCED
CONCRETE PAVEMENTS

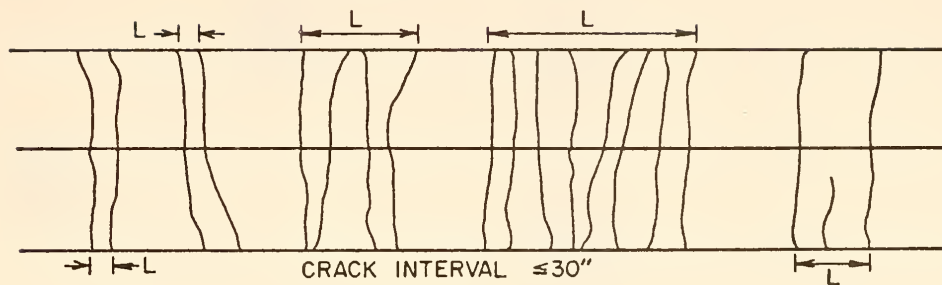
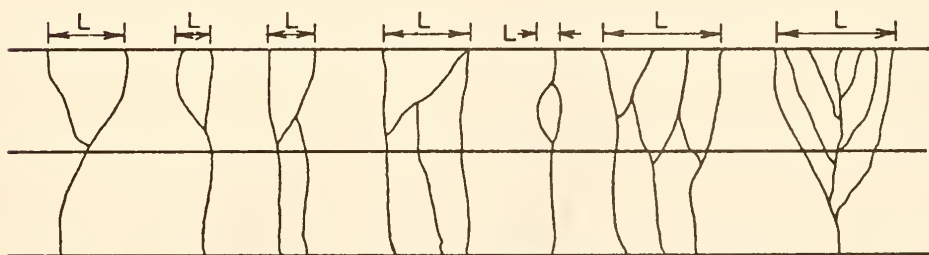
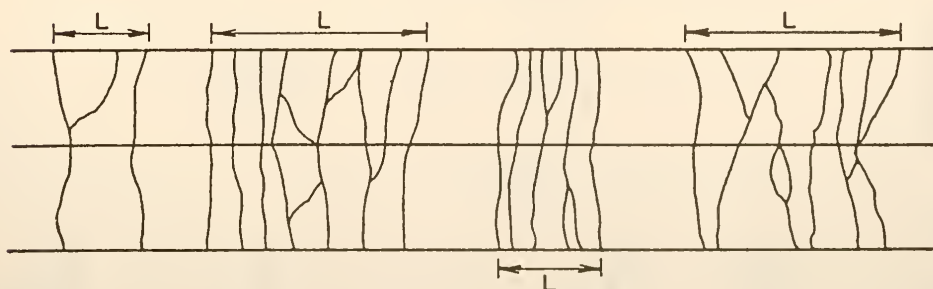
FIGURE 2. TYPICAL CRACK PATTERNS

PARALLEL CRACKS

INTERSECTING CRACKS

COMBINED PARALLEL AND INTERSECTING CRACKS

Deflection measurements and a condition survey of the test pavement were made in the fall of 1974. Deflection readings were taken with the Dynaflect at 25 foot intervals over the study area. The condition survey was made noting the size and location of breakups, and the location and lineal feet of closely spaced parallel cracks, intersecting cracks, and combination cracks. Figure 2 shows the criteria used for determining the lineal feet of cracking. Lineal feet of cracking (L on Figure 2) was the longitudinal distance a specified type of crack was observed.
